How to Diagnose GC Septum Bleed Contamination Sources: Could it be Your Vial Cap?

- Identifying vial cap septum bleed prevents lengthy inlet troubleshooting.
- Reduce interference with correct solvent-septum compatibility.

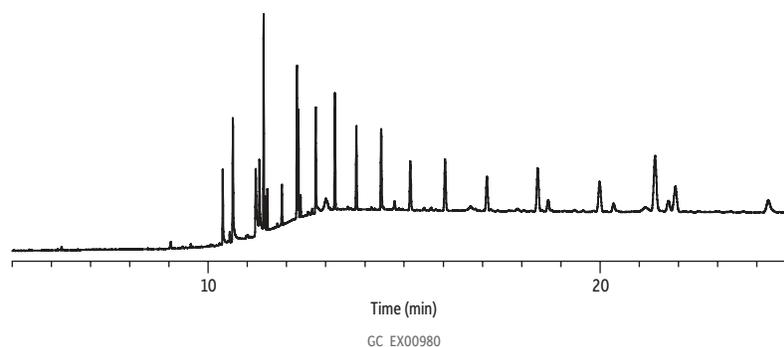
Figure 1: The presence of sharp, repetitive peaks is a characteristic that helps identify GC septum bleed from either the vial cap or inlet.

| Column | Rtx-5MS, 30 m, 0.25 mm ID, 0.25 μ m (cat.# 12623) |
| Sample | Methylene chloride blank |
| Inj. Vol.: | 1.0 μ L split (split ratio 10:1) |
| Liner: | 4.0 mm ID straight inlet liner w/wool (standard deactivation) (cat.# 20782) |
| Inj. Temp.: | 240 $^{\circ}$ C |
| Oven Temp.: | 70 $^{\circ}$ C (hold 1 min) to 290 $^{\circ}$ C at 20 $^{\circ}$ C/min (hold 13 min) |
| Carrier Gas | He, constant flow |
| Flow Rate: | 1.2 mL/min |
| Detector | FID @ 250 $^{\circ}$ C |

The bleed from either septum shows a similar pattern (Figure 1), but it is easy to determine the source with a simple test. Isolate the inlet by setting the instrument to perform a run without an injection. Perform an analysis; if the bleed disappears, then the vial cap septum was the source. Determining if the vial cap septum is the source of the bleed can save time by preventing unnecessary troubleshooting and maintenance. If the problem is in the inlet, review our technical article before replacing the septum. However, if the vial cap septum is causing the bleed, the issue can be eliminated or minimized with the following considerations.

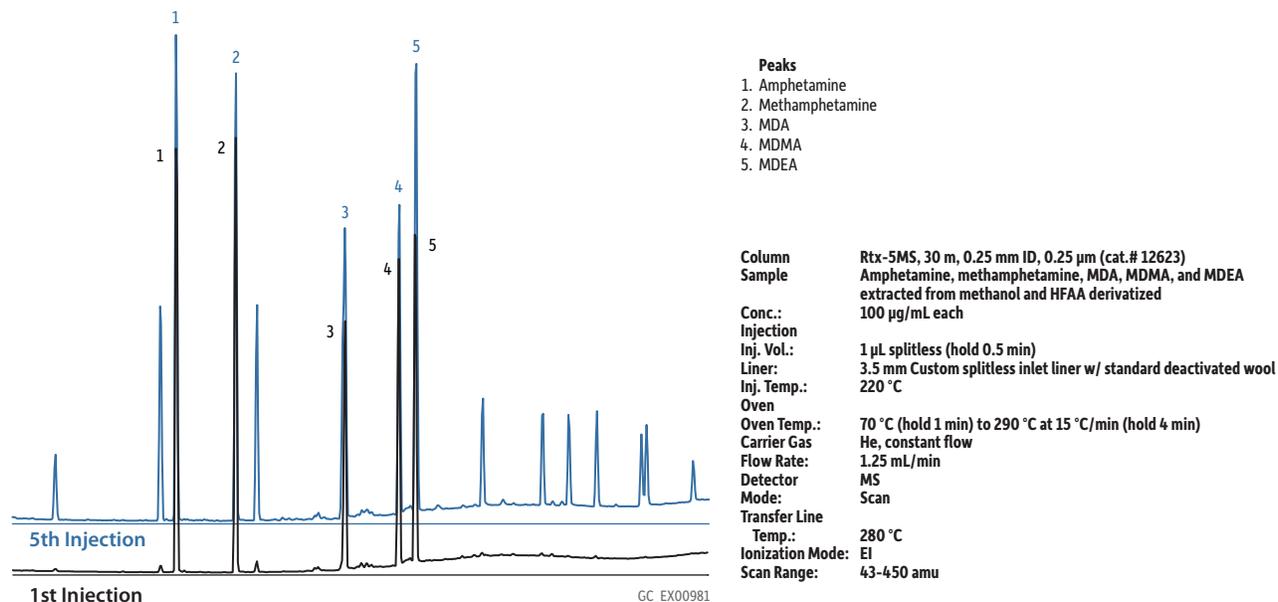
Figure 2: Contamination from septum bleed can cause significant interference with target analytes.

Once you've diagnosed the GC septum bleed source as the vial cap, the first step in resolving the issue is to make sure that the vial cap septum material is compatible with your injection solvent. While septum bleed is not excessive most of the time, when a solvent and vial cap septum are incompatible, extreme contamination can occur. Figure 2 compares the first and fifth injections from a vial containing a derivatized amphetamine sample. In this case, the septum bleed peaks are almost as large as the analyte peaks. This level of bleed can interfere with analyses, especially those geared for trace levels. Reduce the risk of septum bleed by using a compatibility chart to determine which septum material is compatible with the sample solvent used.

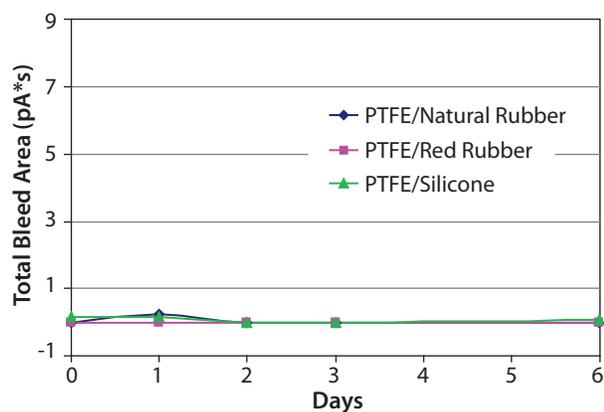
Figure 3: PTFE lining on vial cap septa prevents bleed due to solvent/septum interaction.

Most vial cap septa are lined with a protective layer of polytetrafluoroethylene (PTFE) to prevent solvent attack. As shown in Figure 3, PTFE effectively prevents septum breakdown due to solvent exposure. In comparison, unlined vial cap septa exhibit bleed after just 24 hours at room temperature. Bleed levels for unlined vial cap septa varied by material, but even a low level of bleed can interfere with integration and is of particular concern for trace analyses (Figure 4).

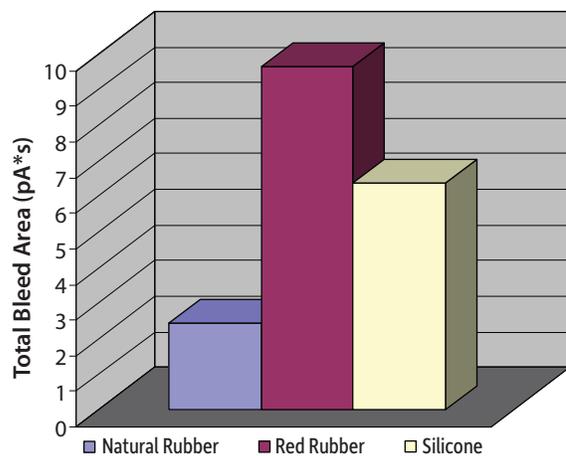
Figure 4: Unlined vial cap septa show bleed contamination within 24 hours.

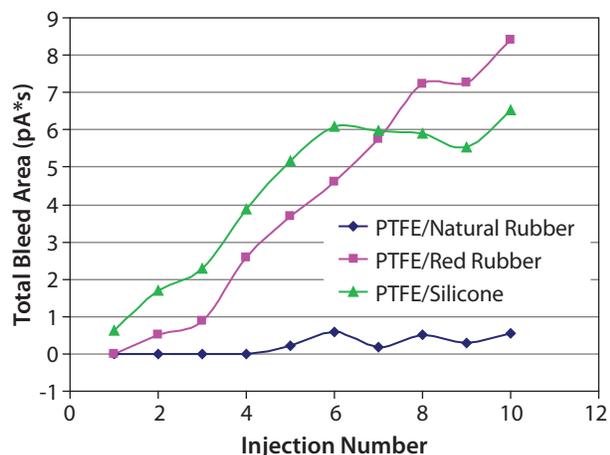
Figure 5: Bleed contamination increases over multiple injections.

Multiple injections can core the vial cap septum and lead to significant GC septum bleed. Resistance to coring varies by septum material (Figure 5). Coring can be minimized by preparing separate vials for replicate injections, when feasible, and by carefully considering the type of septum material when multiple injections are necessary. Septum resealability also affects evaporative loss, which can be a significant source of error for low volume samples. For example, a relatively nonvolatile analyte in a volatile solvent can concentrate significantly due to evaporative loss (Figure 6). Vials should be recapped when necessary for extended runs or long-term storage.

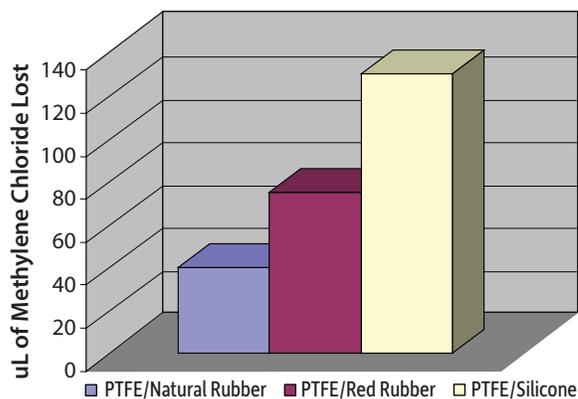
Figure 6: This bar graph shows the volume of solvent lost for three septum types. Vials containing 300 μ L of methylene chloride were punctured and left at room temperature for 24 hours.
